Original Research Article

Mountain Fortresses of Northwestern Iran: A Study on the Risks to Defensive Architectural Heritage*

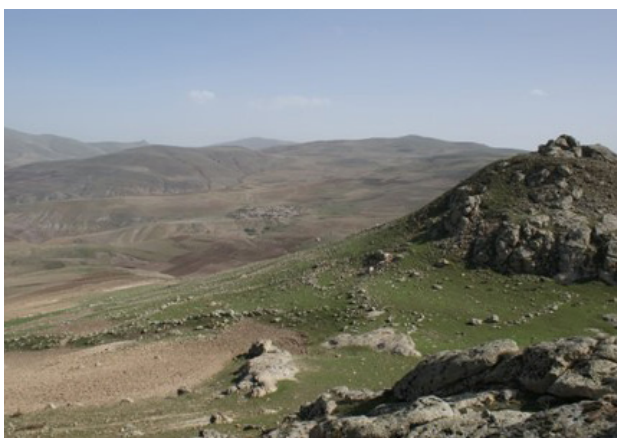
Fig. 2. Architectural spaces around the central castle.
Source: Kazempour et al., 2012.

In the uppermost part of the fortress, traces of stone foundations and defensive walls are still visible on the surface. However, due to the debris from the destruction of upper structures, the exact architectural form and layout of these remains cannot be clearly identified (Fig. 2).

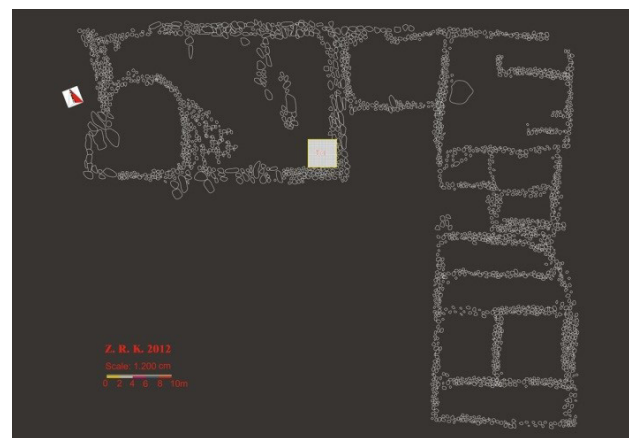
Fig. 3. Plan of the Architectural Space of Zardkhaneh.
Source: Kazempour et al., 2012.

The structures at this site are arranged in a continuous layout extending from east to west and are predominantly characterized by rectangular (quadrangular) plans. The collapse of superstructural materials into the interior spaces of residential units has made the identification of the original architectural layouts difficult. All identified structures follow a four-sided plan, with dimensions ranging from approximately 20 × 30 meters to 4 × 5 meters. The construction technique is based on dry-stone masonry, using unworked stones measuring approximately 40 × 30 cm (Fig. 3). Comparable architectural examples dating to the Iron Age have been identified in several regions, including Armenia (Smith, 2006), Nakhchivan Autonomous Republic (Belli & Konyar, 2003, 85), Anatolia (Rezaloo, 2007), Georgia, as well as in Ardabil Province and East Azerbaijan Province.

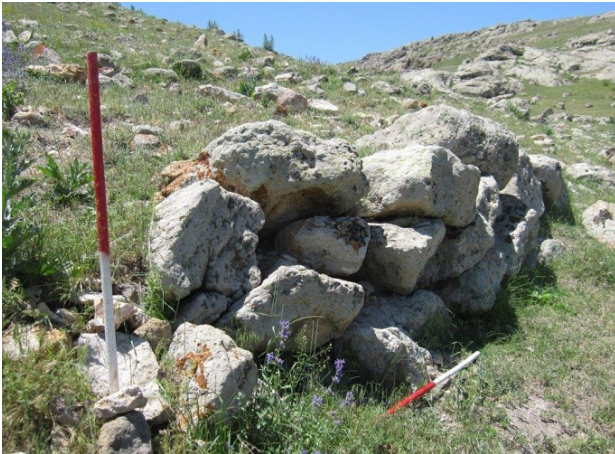
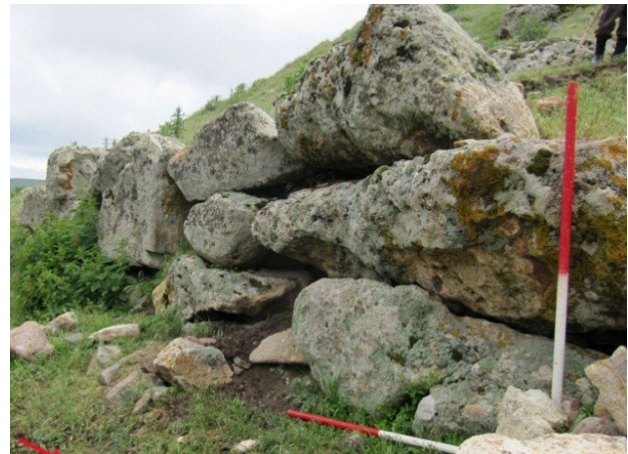
Fig. 4. Fortification walls around the central castle of Zardkhaneh.
Source: Kazempour et al., 2012.

Fig. 5. Fortification walls around the central castle of Zardkhaneh.
Source: Kazempour et al., 2012.

large dry-stone defensive walls can be observed. These structures were built using locally available stones of varying sizes extracted from the surrounding area. The stone masonry along the ridges and summit is generally irregular, and in some sections, stones have collapsed and rolled down the slope. In contrast, the stone walls on the northern slope of the site are more orderly and demonstrate a clearer structural organization. Here, the defensive walls are arranged sequentially in accordance with the natural gradient of the terrain. In several areas, evidence of land leveling and the modification of natural slopes through large-scale stone constructions can also be observed. The construction material consists entirely of unworked local stone, with considerable variation in size, some blocks reaching up to 2 meters in length. The stones were laid using a dry-stone technique, without mortar. In addition to the perimeter defensive walls, traces of stone structures are also visible around Hill C. Evidence suggests that in the southern and eastern parts of the fortress, due to the steep slopes and vertical rock formations, defensive walls were not constructed. However, in the northern sector, multiple layers of defensive walls were built in a nested arrangement, with several meters of spacing between each line of defense. Although the exact thickness of the walls cannot be precisely determined due to extensive collapse, surviving remains indicate an average thickness of approximately 1 to 1.5 meters (Figs. 4 & 5).

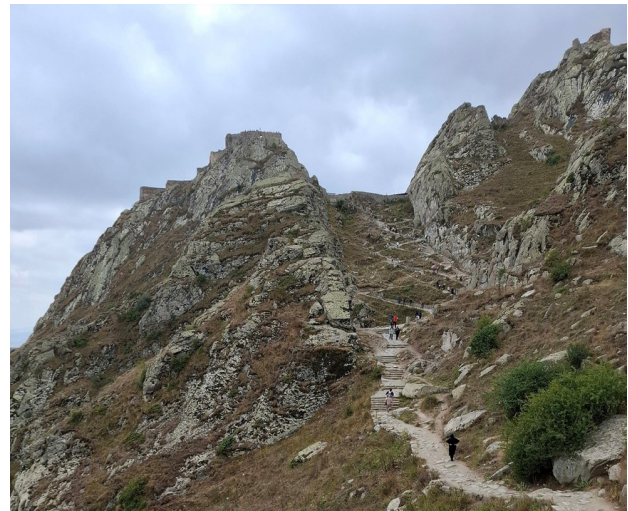
Fig. 6. The Architectural Structure of Babak Castle.
Photo: Mehdi Kazempour, 2025.

allow water to penetrate cracks within the stone walls; upon freezing, the expansion of water widens these cracks, gradually weakening the cohesion of the mortar and causing localized collapse of masonry elements. In addition, heavy rainfall and surface runoff have intensified the erosion of the rock foundation beneath the castle. Since this bedrock serves as the natural foundation of the structure, its gradual destabilization poses a serious risk to the overall integrity of the fortress and may even lead to slope instability or partial landslides. Alongside natural factors, inappropriate human interventions such as unscientific restoration practices, historical stone removal, and uncontrolled tourism pressure have further aggravated the damage. Effective conservation of Babak Castle requires a comprehensive and multi-layered approach that considers both its architectural characteristics and its natural geological setting. The first step involves

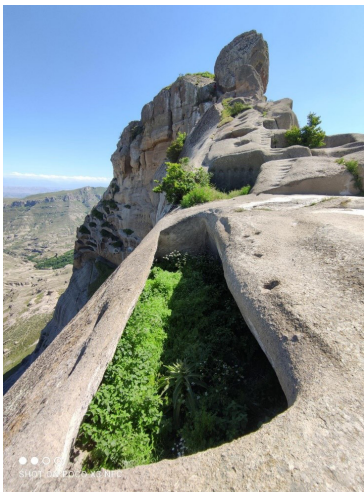
Fig. 9. Architectural spaces carved into the stone bed of Peshtab castle. Photo: Mehdi Kazempour, 2023.

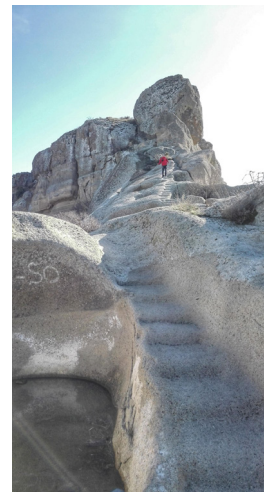
Fig. 10. Stairs carved into the rocky bed of Peshtab castle. Photo: Mehdi Kazempour, 2023.

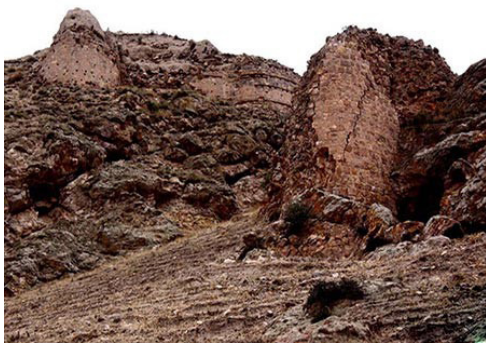
Fig. 11. Material uses at Nodouz castle. Photo: Mehdi Kazempour, 2022.

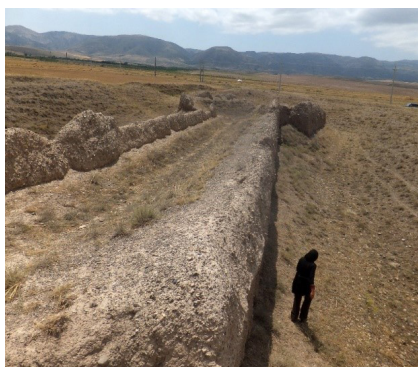
Fig. 15. One of the brick towers of Kalfir castle.
Photo: Reza Salmanpour, 2016.

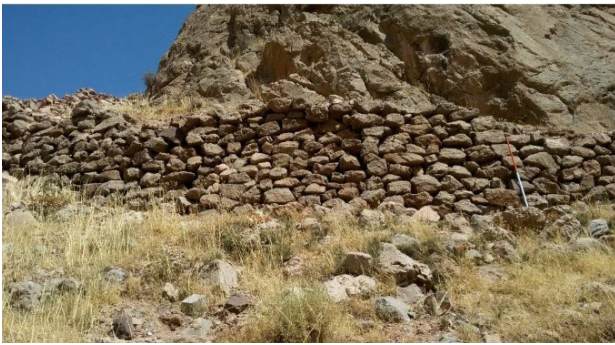
Fig. 17. Maragheh Kizlar castle fortification.
Source: Naseri Som'eh et al., 2019.

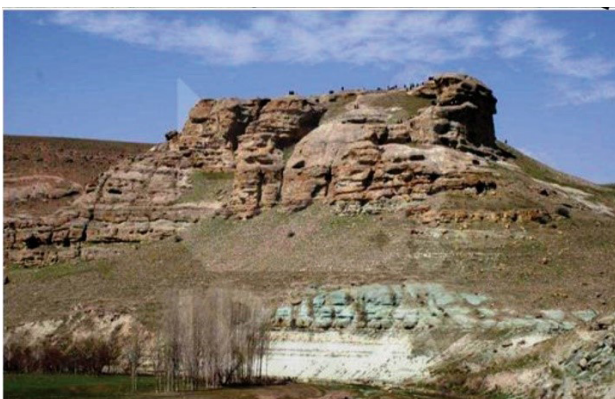
Fig. 19. stone structure of Goyjeh Castle, Maragheh.
Source: Naseri Som'eh et al., 2015.

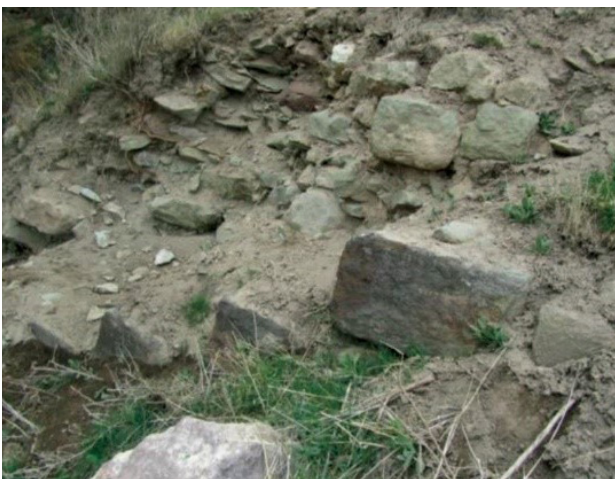
Fig. 20. A hand-carved on the rocky bed of Goyjeh Castle, Maragheh. Source: Naseri Som'eh et al., 2015.
